CHURCH OF ST NICHOLAS

Quinquennial Inspection Report

August 2011

St Nicholas, Yate
Quinquennial Inspection Report

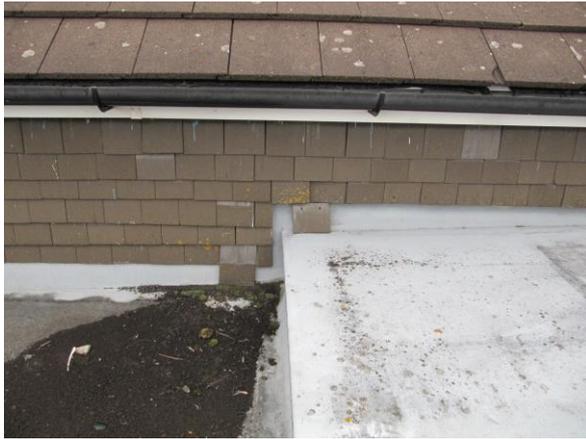
- South Wall above flat roof:
The tile hanging is generally in good condition, but there are some slipped tiles near the east entrance roof. Also some missing tiles on wall gable above flat roof.*Photograph 1*
Roof ventilator cap on Quiet Room roof is broken.

- South Wall:
 - Slipped tiles on Church wall above flat roof.*Photograph 1*
 - Precast concrete panels are in good condition.
 - Sealant in joints appears generally sound.

Photograph 1
Church south wall above flat roof -
slipped cladding tiles/damaged eaves
tile.

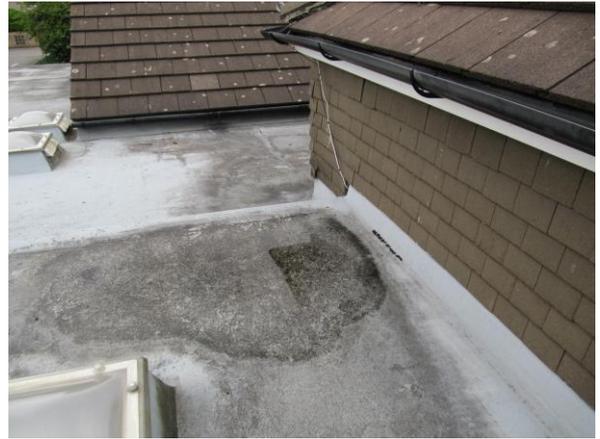
- Crack in upstand at south side of east entrance.
- Ponding by south west corner of church.*Photograph 3*
- Channel beside the church west wall is full of debris.*Photograph 5*

Photograph 3
Church – ponding on entrance hall roof.

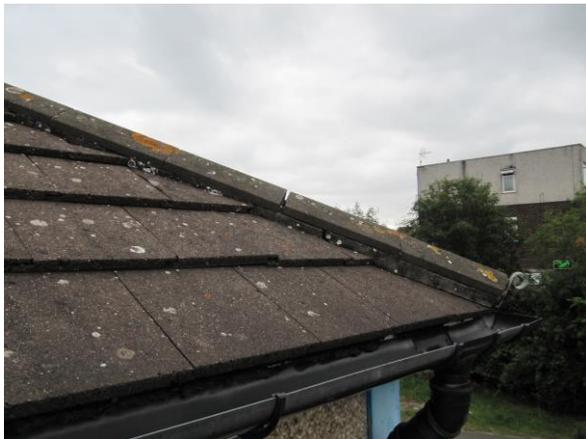
- Church West Slope:
Concrete interlocking tiles in good condition.
Spire appears sound.
South West hip. Lowest five hip tiles are becoming dislodged. There is a loose part tile underneath the lowest hip tile.

Photograph 2
Church south west hip – dislocated hip
tiles at eaves.

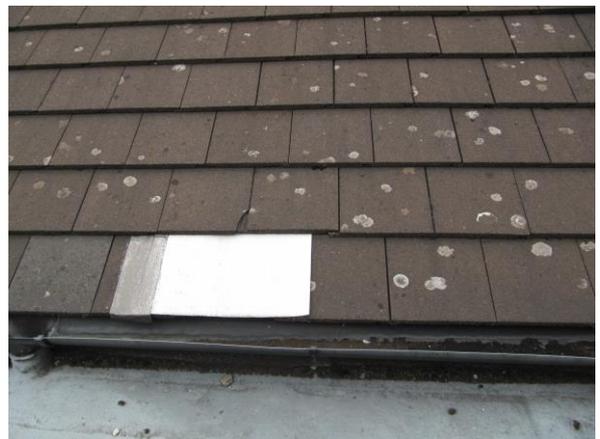
- Roof and gutter outlets have no cages to prevent debris entering the drainage system.
- Hall East Slope:
Concrete interlocking tiles in good condition apart from missing tile in bottom course, where there is temporary protection with plastic sheet.*Photograph 4*

Photograph 4
Hall – broken and missing roof tiles.

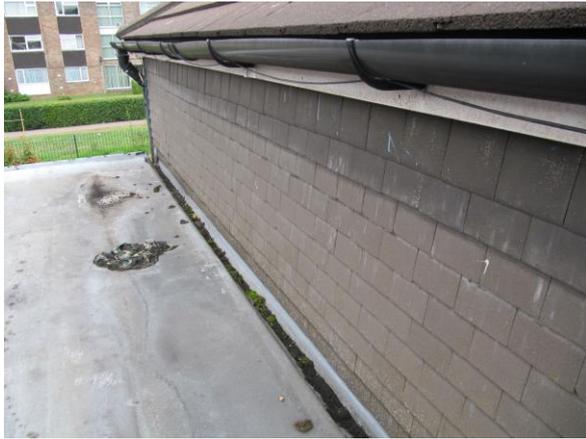
Photograph 5
Church – clogged channel over vestry

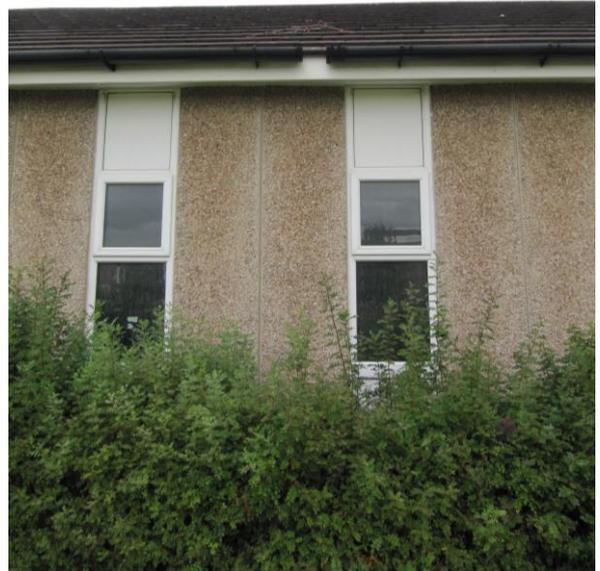
The west gutter to the hall has a short section missing in the centre. .*Photograph 7*
The lower pipe clip to the north east downpipe is damaged.

Photograph 7
Hall – missing section of gutter west side.

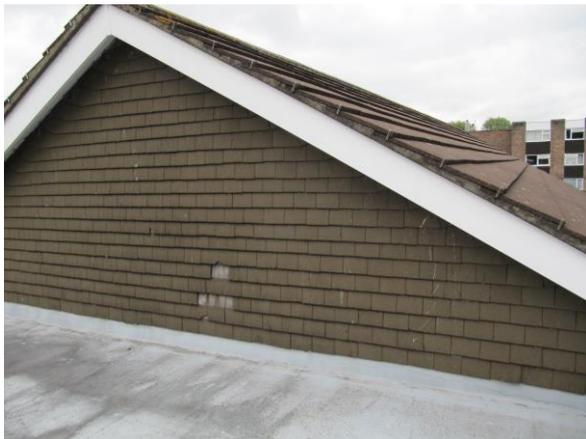
- Slipped/missing tiles on Hall wall above flat roof.....*Photograph 6*
 - Plastic fascias are in good condition.
- West Wall (Willow Room and Hall):
 - Precast concrete panels and fascia are in good condition.

Photograph 6
Hall – broken/missing cladding tiles to south gable above flat roof.

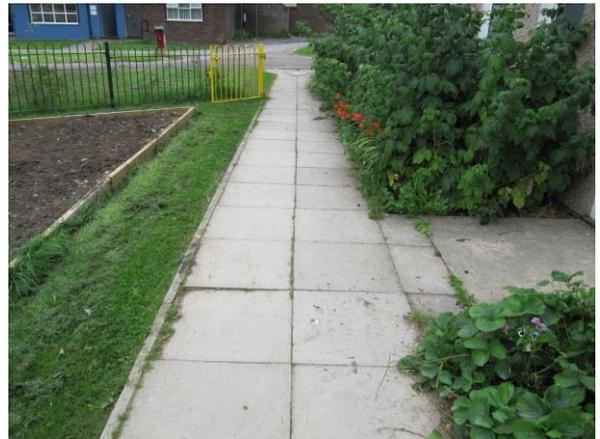
North and west paths also in concrete paving slabs is generally in good order, although one cracked slab was noted and grass beginning to grow in some of the joints.

Photograph 8
North Path – uneven paving slabs/vegetation in joints.

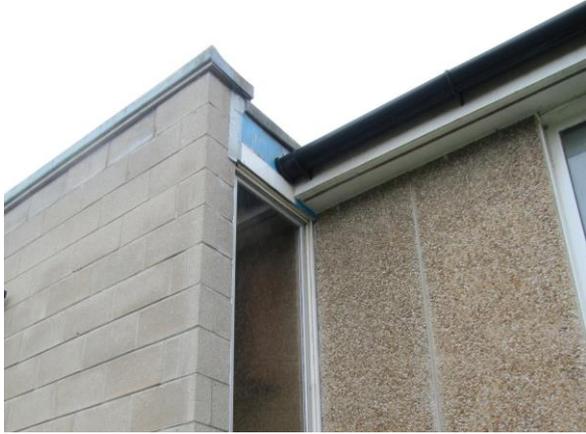
Photograph 9

- External material is concrete blockwork which is sound.
 - There is a temporary repair between the fascia and the block wall above the window facing west.*Photograph 9*

Church – north wall, west facing window showing temporary repair at junction with blockwork.

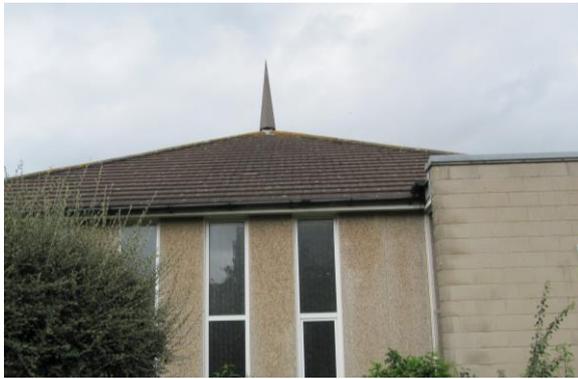
Photograph 10

- Church East Slope:
There is one slipped tile in the middle of the roof.*Photograph 10*

Church East Roof Slope – slipped roof tile.

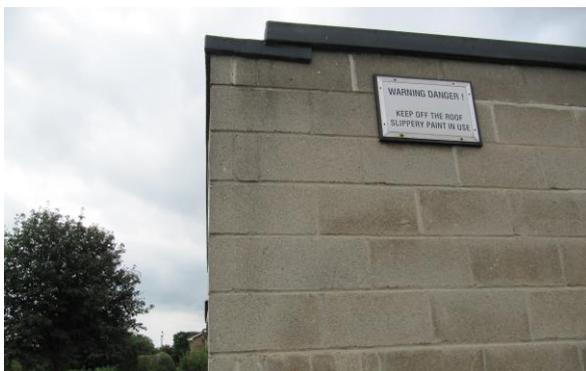
Photograph 11

Some of the flat roofs have parapets and viewed from the roof they appear to be in good condition. Viewed from ground level it was noticed that there was evidence of some movement in the high level blockwork at the north east corner of the quiet room. Small gaps have opened up in the mortar between some of the blocks.

Quiet Room – North East parapet showing movement in joints on top course of blocks.
